Manhole Inspection Summary

Manhole # S55K__072MH

Insp Date: **6/2/08 1:38 PM**

Location Address: **3712 fait ave**

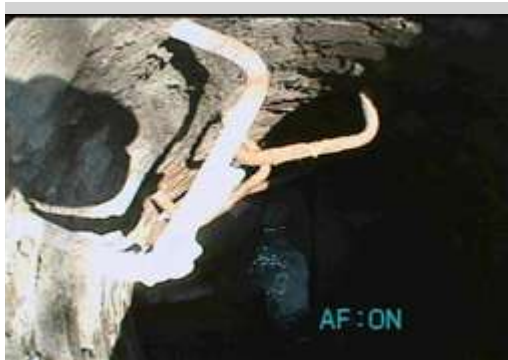
Defect 2

Steps Count: **6** Missing: **1** ☒ Corroded

corroded steps

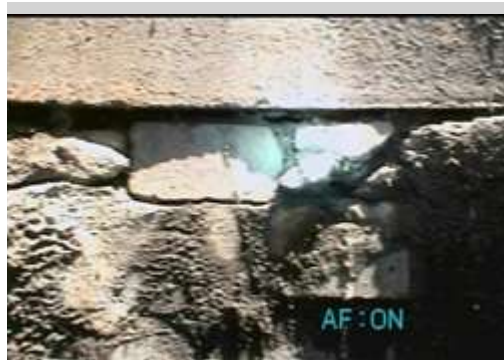
Defect 1

Condition: ☐ Sound ☐ Cracked ☐ Root Intrusion ☒ Loose Brick ☒ Deteriorated

loose bricks & deteriorated chimney

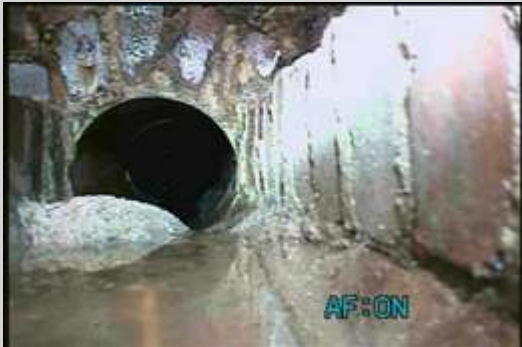
12 O'Clock Outflow

8 in. Circular Gravity Sewer
Pipe Out @ 12 O'Clock

Invert Depth: **8.50** (ft.) Flow Characteristics: **Slow**

Deposits: ☒ None ☐ Mud ☐ Sludge ☐ Debris ☐ Grease

Infiltration: **None** Pipe Seal Cond: **Unknown**

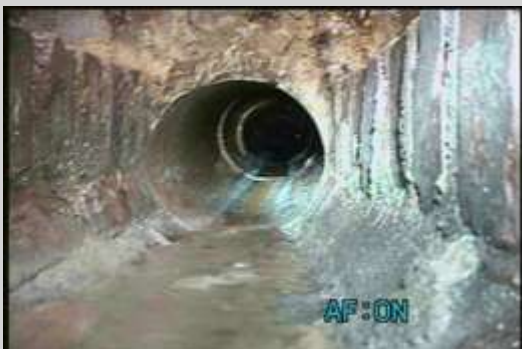
6 O'Clock Inflow

8 in. Circular Gravity Sewer
Pipe In @ 6 O'Clock

Invert Depth: **8.30** (ft.) Flow Characteristics: **Slow**

Deposits: ☒ None ☐ Mud ☐ Sludge ☐ Debris ☐ Grease

Infiltration: **None** Pipe Seal Cond: **Unknown**

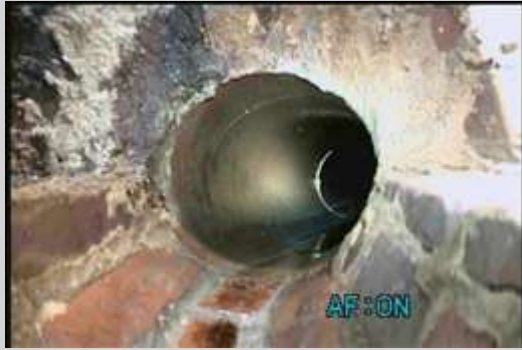
9 O'Clock Inflow

8 in. Circular Gravity Sewer
Pipe In @ 9 O'Clock

Invert Depth: **8.30** (ft.) Flow Characteristics: **Slow**

Deposits: ☒ None ☐ Mud ☐ Sludge ☐ Debris ☐ Grease

Infiltration: **None** Pipe Seal Cond: **Unknown**
